检测报告  
Test Report

报告编号 A2240786069101001E

样品名称	载带
Sample Name	Carrier band
样品接收状态	正常
Sample Receiving State	Normal
样品接收日期	2024.12.13
Sample Received Date	Dec. 13, 2024
样品检测日期	2024.12.13-2024.12.26
Testing Period	Dec. 13, 2024-Dec. 26, 2024

测试项目：高温试验  
Test Item: High temperature test

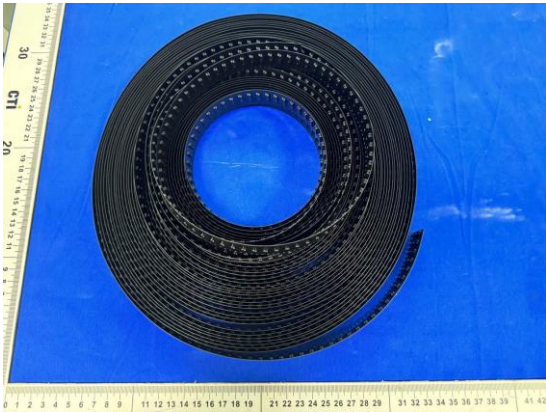
样品编号 Sample No.	样品名称 Sample Name	样品数量 Quantity
A2240786069101001	载带 Carrier band	1pc

样品图片

Sample Photo(s)

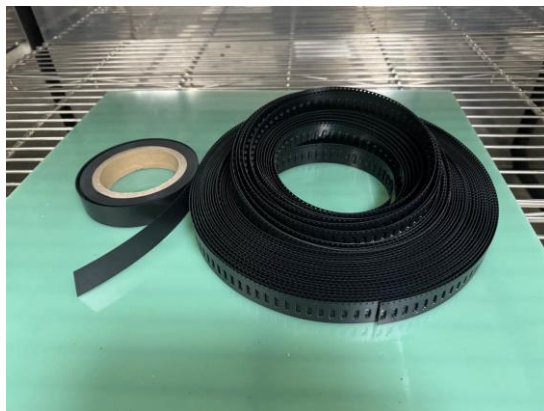
测试图片

Test Photo(s)

Test Condition  
测试温度：45℃  
温变速率：≤1℃/min  
测试时间：192 小时  
Test temperature:45℃  
Temperature change rate:≤1℃/min  
Test duration:192h

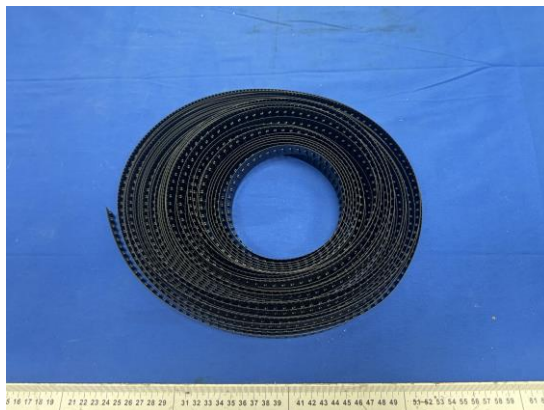
样品编号 Sample No.	测试结果（目视检查） Test result (Visual inspection)
A2240786069101001	样品外观无明显变化 There was no obvious change in the appearance of the sample

测试后样品图片

Sample Photo(s) after the test
